E2 ReBuild

Industrial Energy Efficient
Retrofitting of Resident
Buildings in Cold Climates

D2.2 Demonstrator Oulu

Project no:	260058	Project acronym:	E2ReBuild
Due date:	2014-06-30	Submission date:	2014-06-24
Dissemination:	Public		
Partners:	<u>Aalto</u> ; NCCFI, PSOAS		
Authors:	<u>Simon le Roux</u>

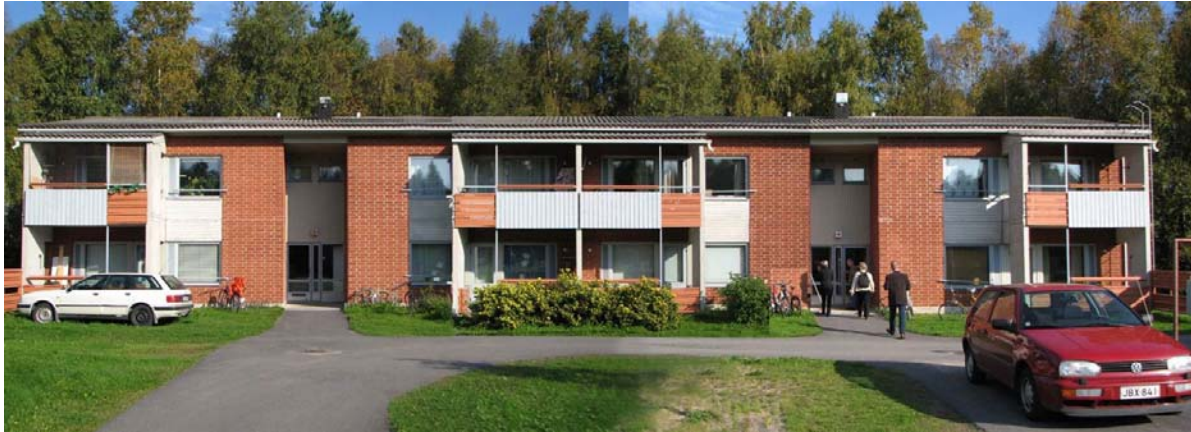
Figure 1: Virkakatu 8AB, Oulu demonstration object prior to refurbishment (photo collage, S. le Roux, 9.9.2011)

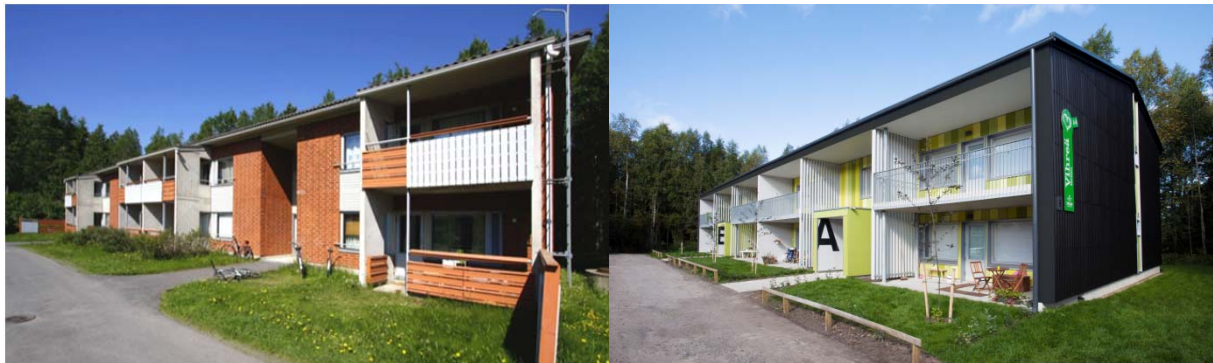
Figure 3: Oulu demonstration before retrofit in 2011 and at completion in 2013 (photos M3 Architects)

The Oulu demonstration underwent a complete retrofitting of the envelope. The outer façade layers of the existing prefabricated concrete sandwich elements were removed leaving only the inner concrete layer in place. A new façade was retrofitted using prefabricated timber based elements. The old roof was replaced completely by a new timber truss roof and a new thermal insulation layer of 550 mm blown loose fill mineral wool resulting in a U-value of 0.08 W/m²K. The existing ground floor slab was replaced, with a new in-situ ground floor slab with 200 mm graphite-enhanced EPS insulation.

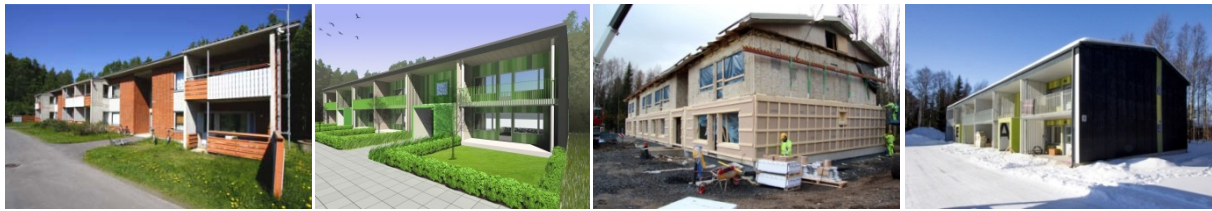
Figure 6: Building in 2011, design stage 2012, TES assembly phase in 2012, and completed in 2013 (photos M3 Architects)

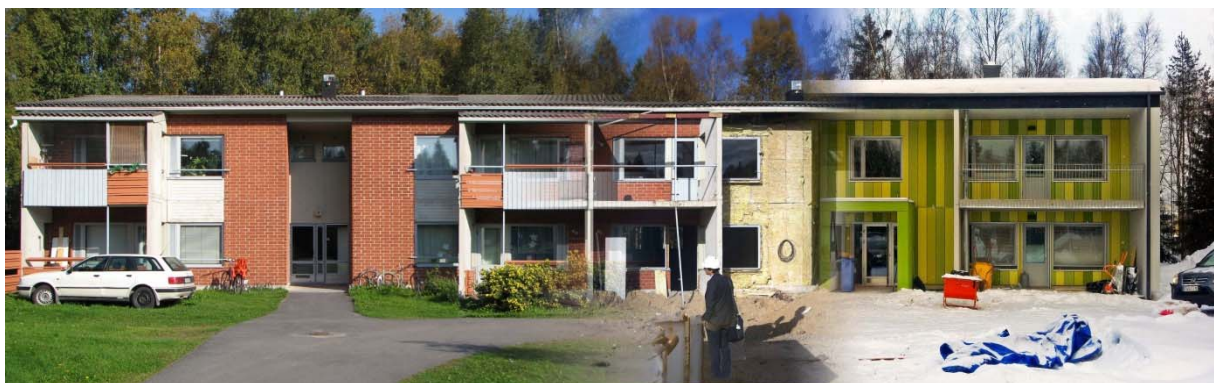
Figure 9: Retrofit process collage. From left: original state 2011, demolition phase 2012, and finishing off 2013 (S. le Roux)

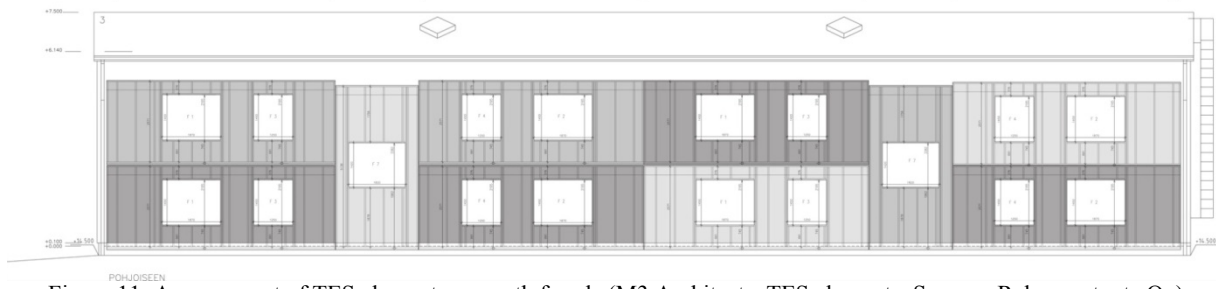
Figure 11: Arrangement of TES elements on north facade (M3 Architects; TES elements: Suomen Rakennustuote Oy)

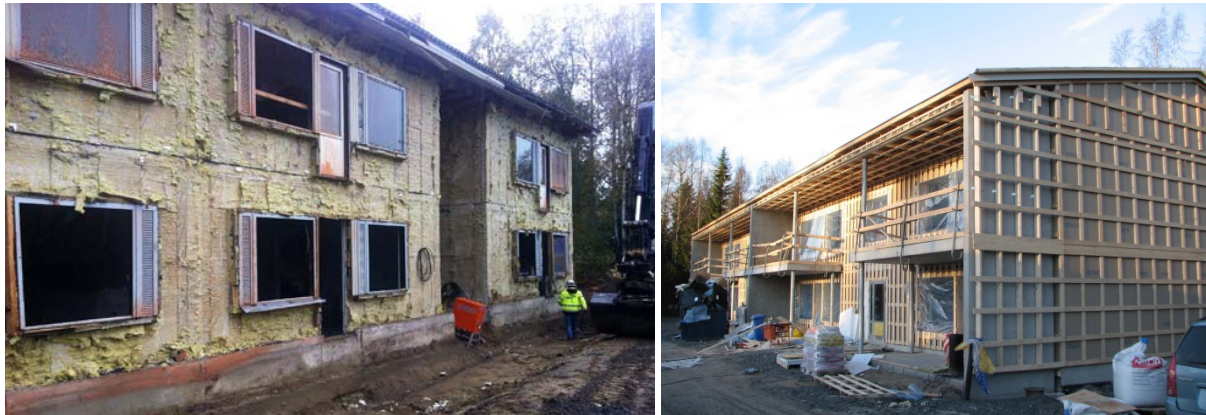
Figure 12: Removal of the external layer of precast concrete sandwich elements in September 2012, and completed assembly in November 2012 of prefabricated timber facade elements, concrete balconies with steel supports, and a new roof assembled on site and lifted into place in 4 large sections (photos S. le Roux, September and November 2012).

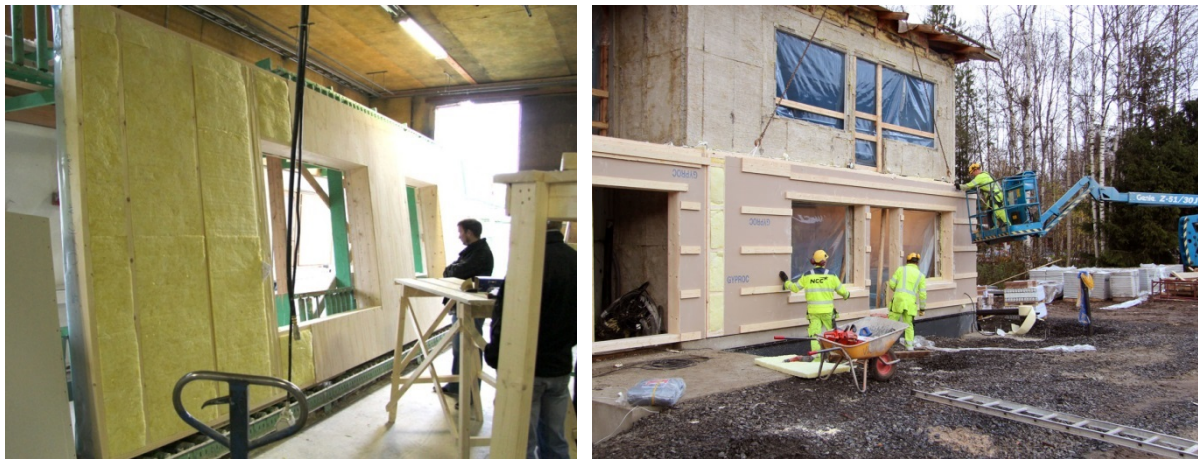
Figure 13: TES element prefabrication in Haapavesi and assembly on site (photos M3 Architects, 2012)

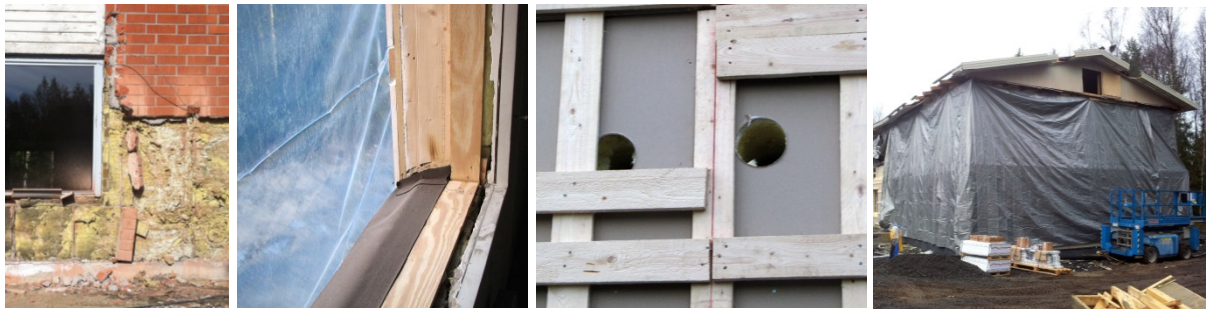
Figure 15: Critical site details: partial demolition, window sill sealing, ventilation penetrations, rain protection (S. le Roux). Site management quality is needed to respond appropriately to existing conditions, maintain site waste management, ensure structural integrity, deliver good air tightness and moisture control, and accurately assemble and protect retrofit components.

The experience revealed that refurbishment not only relies on carefully measured prefabrication with standards in quality control, but also careful handwork and exacting machine work on site. This is clearly an area of specialization, and should be recognized as a future need for improved competency, as contractors gain valuable experience from demonstration projects like E2ReBuild.

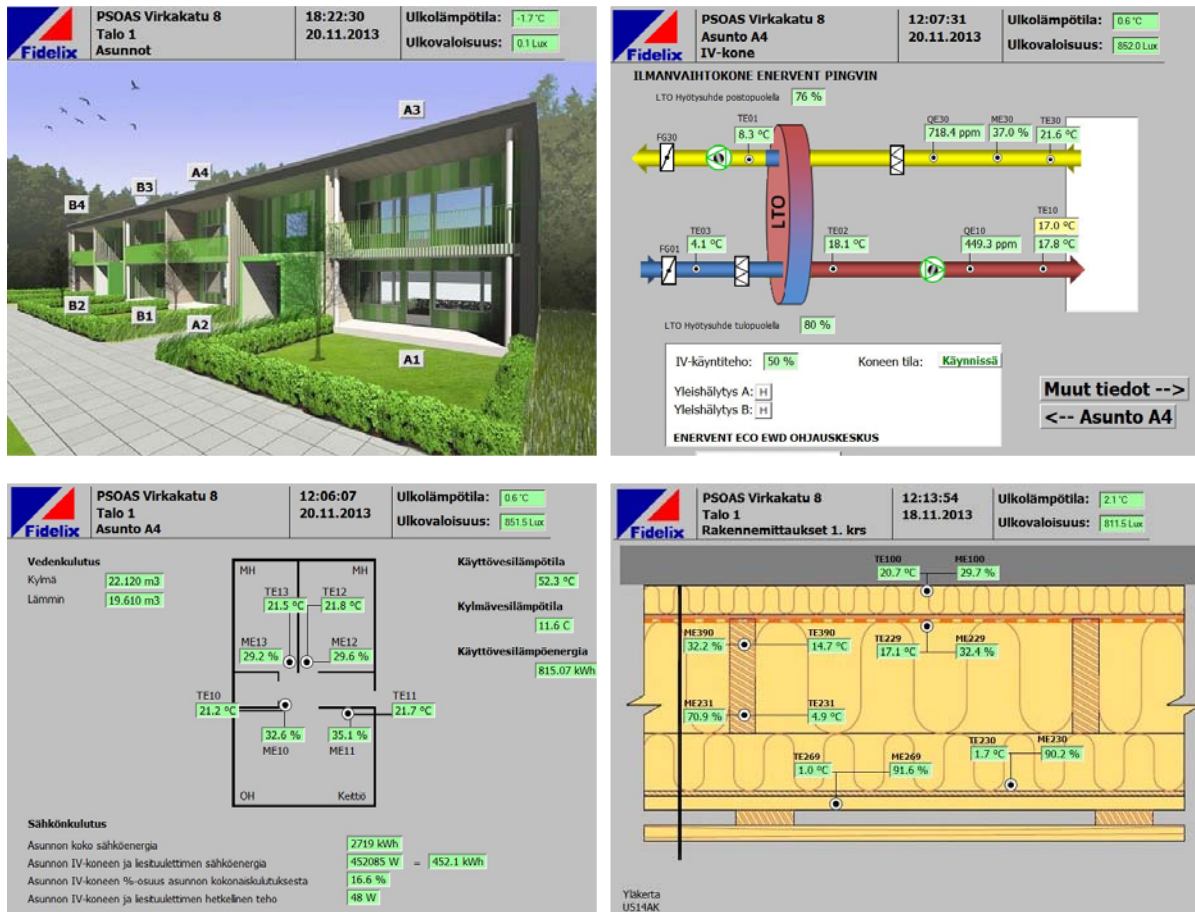
Figure 16: Screenshots from the online interface of the digital building automation system accessing monitoring data. Top left image shows the links to the monitoring data from eight apartments A1-B4. Top right image displays monitoring parameters as collected from all eight apartment ventilation units. Bottom-left image displays household energy use, and indoor temperature and relative humidity data as monitored in two apartments. Bottom right image displays building physics monitoring of temperature and relative humidity in one of the four monitored façade locations (Palosaari M, Fidelix. 2013)

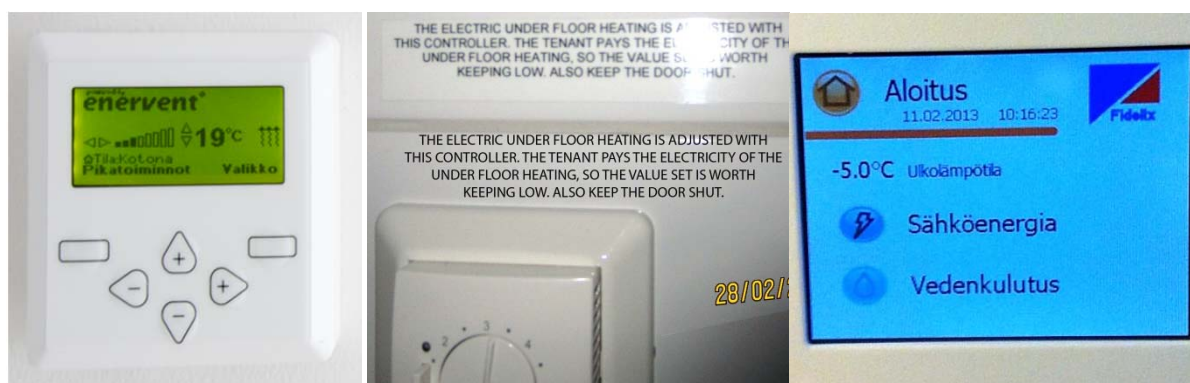
Figure 19: Tenants may adjust ventilation settings, control underfloor heating, and follow their electricity and water use. Radiators can be adjusted. The use of the cooker extractor fan automatically reduces the ventilation unit fan power, to balance the apartment air pressure.

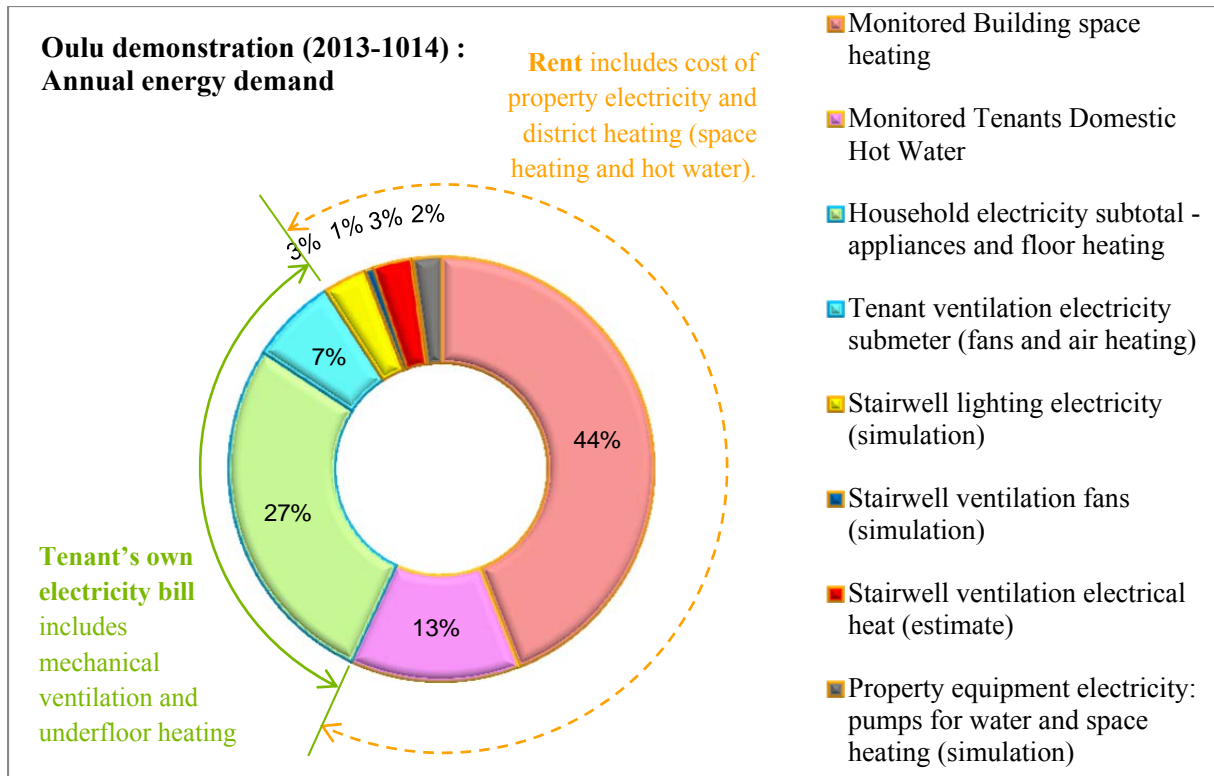
Figure 23: Distribution of monitored energy use, including tenants and owners, electricity and district heat (S. le Roux 2014). Tenants pay for 38% of the total energy consumption in private electricity contracts. As much as half of the tenants' electricity is used for mechanical ventilation and for underfloor comfort heating in bathrooms. The owner pays for district heating, hot water, and property electricity. Monthly fluctuations in heating costs use are not passed to residents.

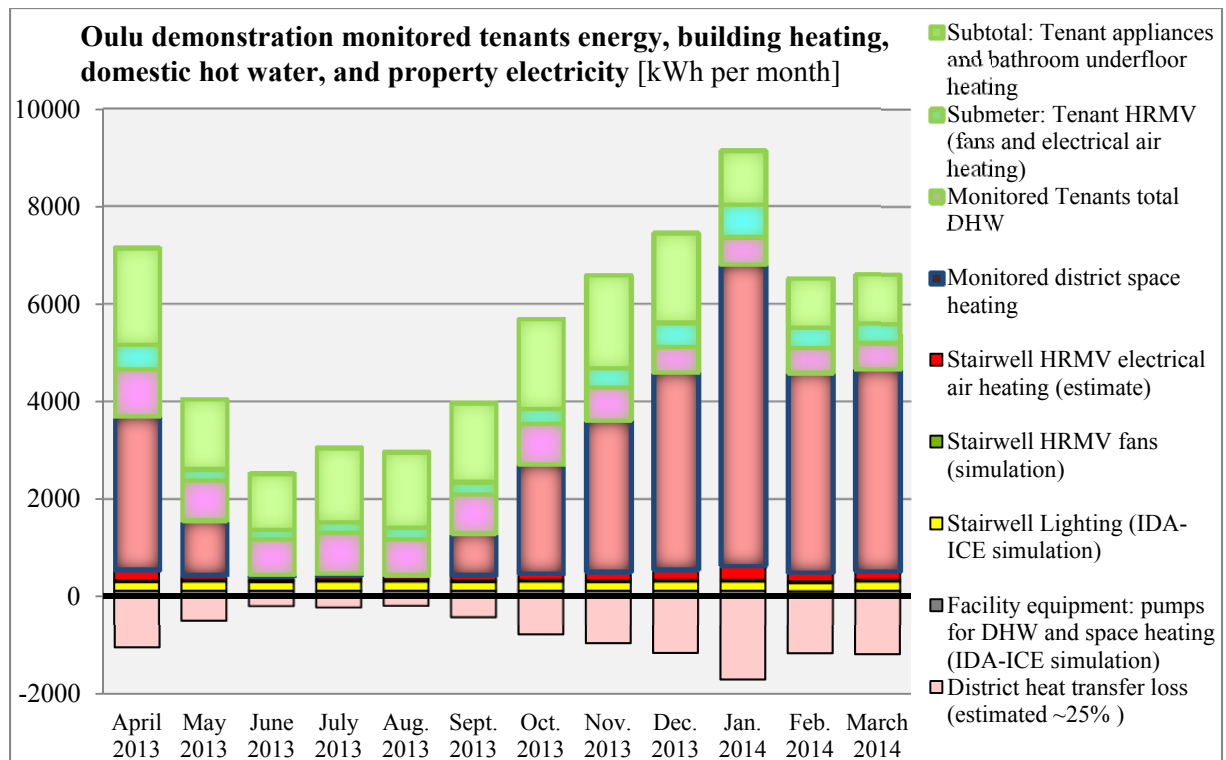
Figure 25: Detailed monthly breakdown of E2ReBuild monitored energy results of the Oulu demonstration. (S. le Roux 2014). D5.1 defines the monitoring system boundary as the building envelope, therefore excluding the district heat transfer loss from the service building to the demonstration building. Heat loss was calculated from available data, and is included for consideration in replication. Heating monitoring shows how weather fluctuations affect real time performance, especially in January 2014, when outdoor temperatures were between minus 15°C and 20°C for four weeks (9.1.2014 to 4.2.2014).

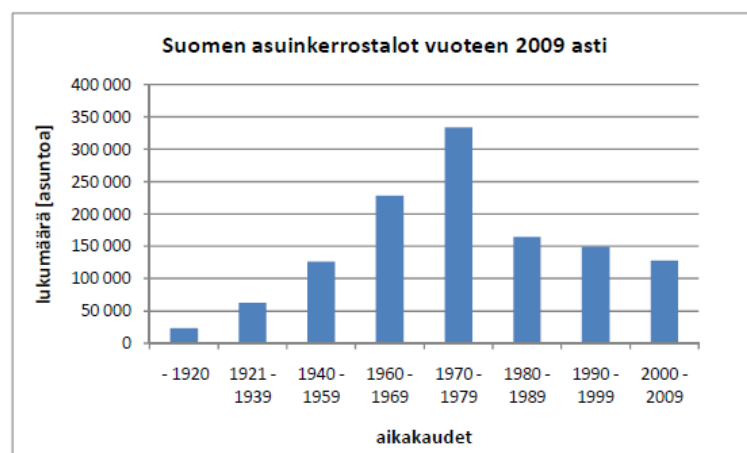
Kuva 1.3. Asuntorakentaminen Suomessa eri aikakausina [Tilastokeskus, 2010]

Figure 28: Apartments in multi-storey apartment buildings built in Finland until 2010 (Statistics Finland, 2010)²⁵

The typology of the Oulu demonstration object may be seen in other building typical of the era (1946-1979), up to the mid 1980's, which represent the bulk of Finnish industrialized housing production from the post-war era. The first TES retrofit in Riihimäki²³ in Finland was a similar building type, and similar buildings have been proposed for future retrofits (e.g. Siltamäki housing area in Helsinki). It has been calculated that there are a total of 44 million m² of concrete facades in Finland, and of the 30000 apartment buildings built in 1965 – 1995, the majority is built with prefabricated facades and balconies. The repair costs of these facades were estimated in 2000 to be 125 million euro annually.²⁴

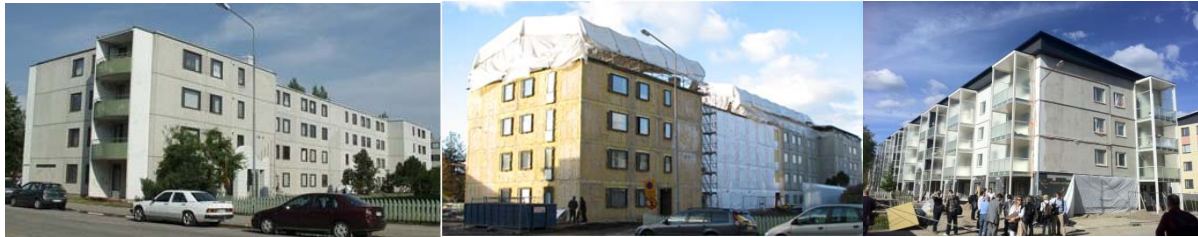
Figure 29: Riihimäki Innova project before TES retrofit, during facade assembly, and completed (S. le Roux 2011-2012)

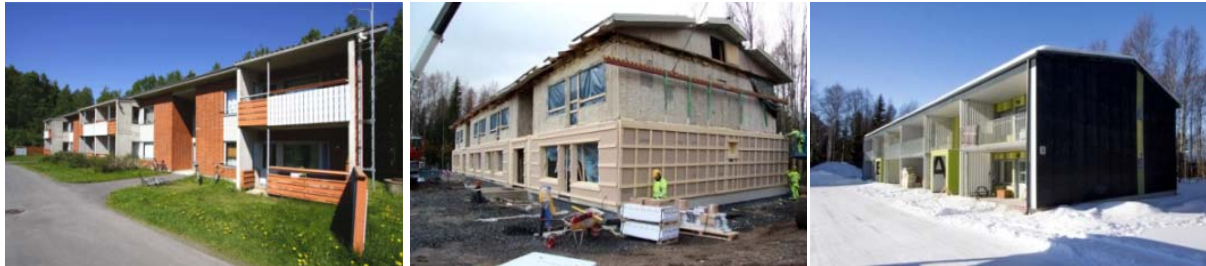
Figure 30: Oulu demonstration project in 2011, TES assembly phase in 2012, and completed in 2013 (photos M3 Architects)
